BACK IN ACTION

At one of Northern Virginia's most complex and notoriously congested intersections, the superstructure of a critical highway overpass was demolished, removed, and replaced in a single weekend.

The design's accelerated bridge construction techniques included three composite units that were prefabricated off-site and a customized very early strength latex concrete mix for the deck closure that provided the cure time, strength, and durability necessary to get the job done on time.

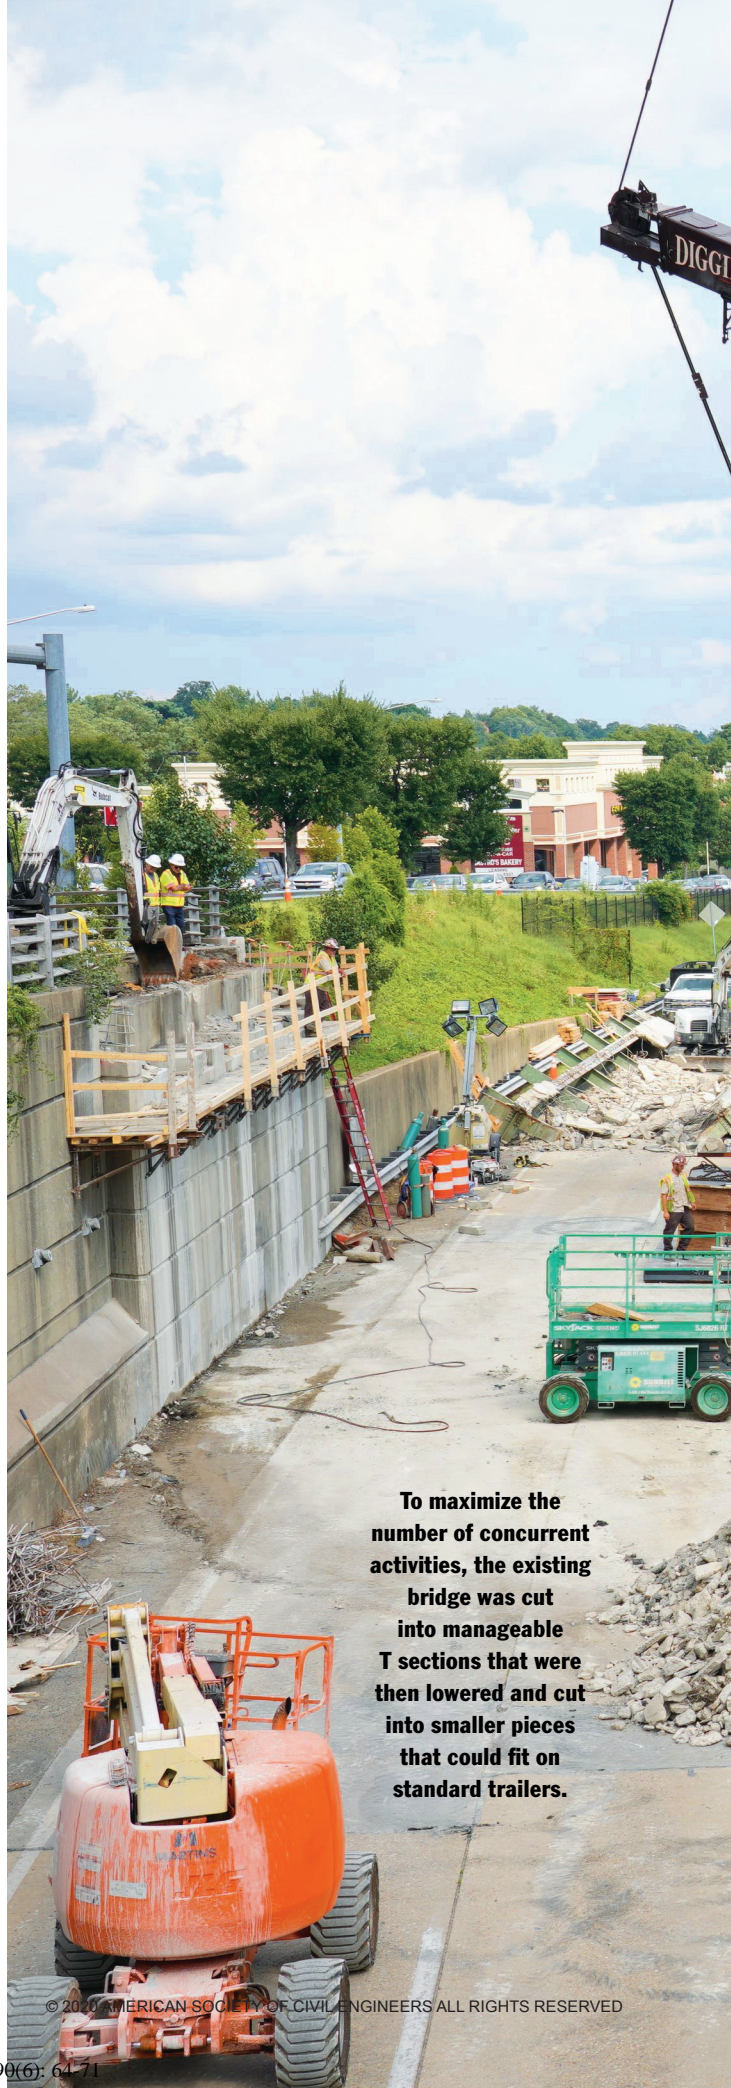
To maximize the number of concurrent activities, the existing bridge was cut into manageable T sections that were then lowered and cut into smaller pieces that could fit on standard trailers.

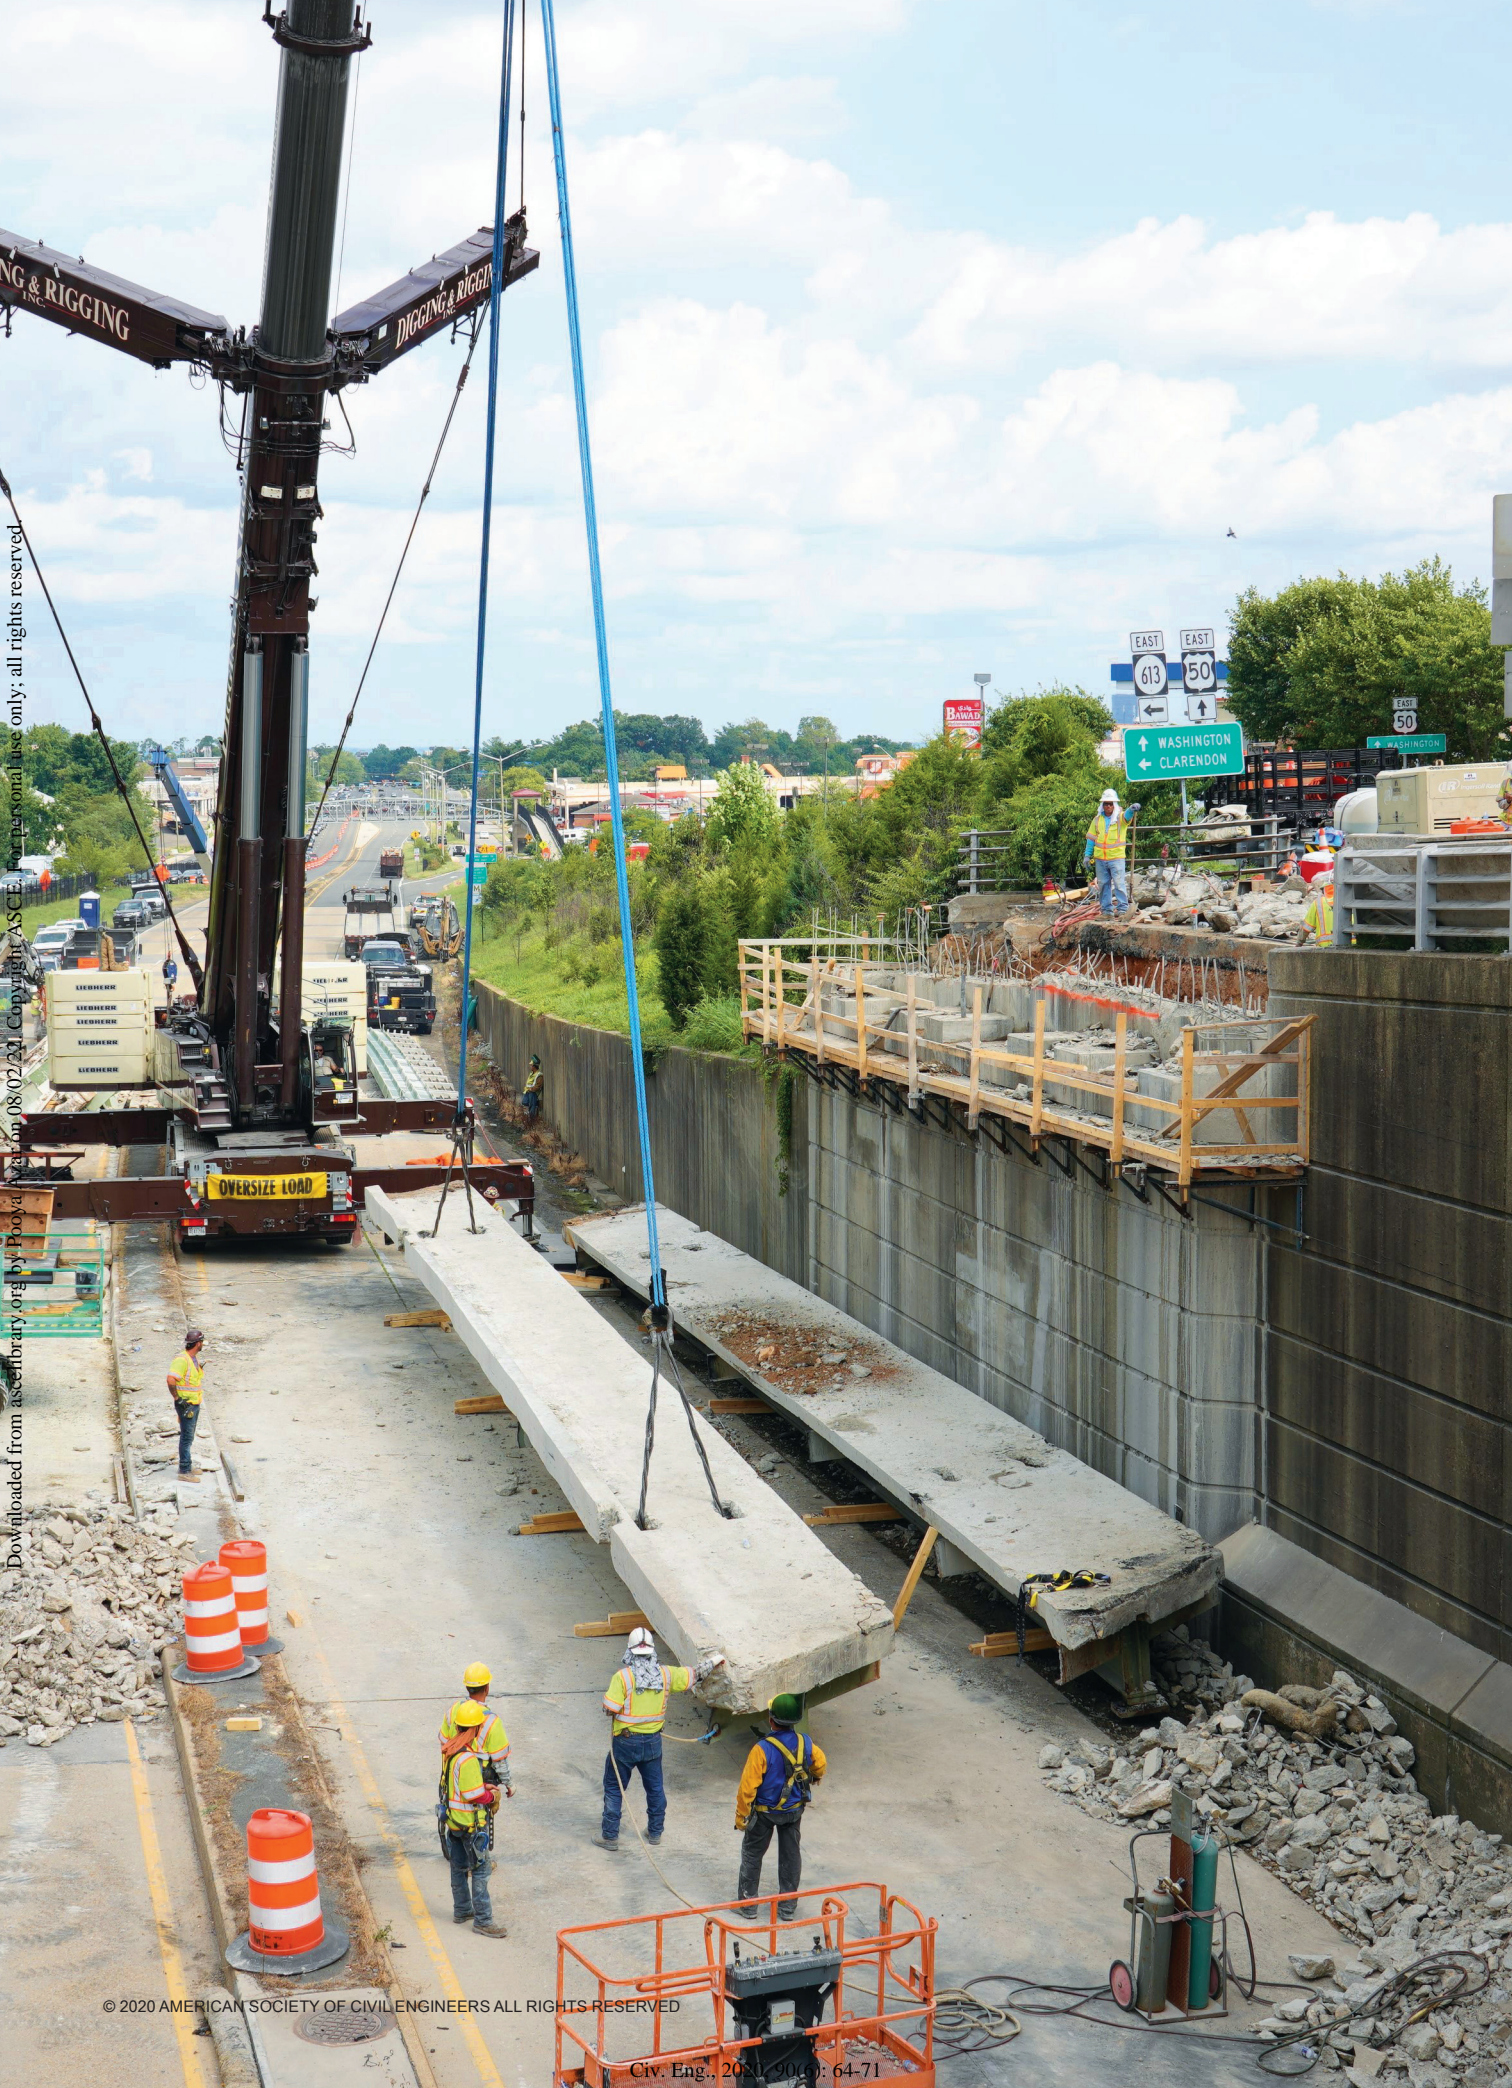
Off-site casting yard

Space in an unused parking lot along Route 50, just 0.4 mi from the project site, was leased for use in prefabricating the preconstructed composite units (PCUs).

The design of the replacement superstructure centered on the prefabrication of three preconstructed composite units (PCUs) built off-site. Each PCU was approximately 87 ft long and included two steel plate girders, each with a 27 in. web depth and an 8 in. deep composite concrete deck slab. The PCUs were each separated by a 3 ft, 7 in. opening that would be cast in place as a closure section and would provide the continuous final bridge deck.

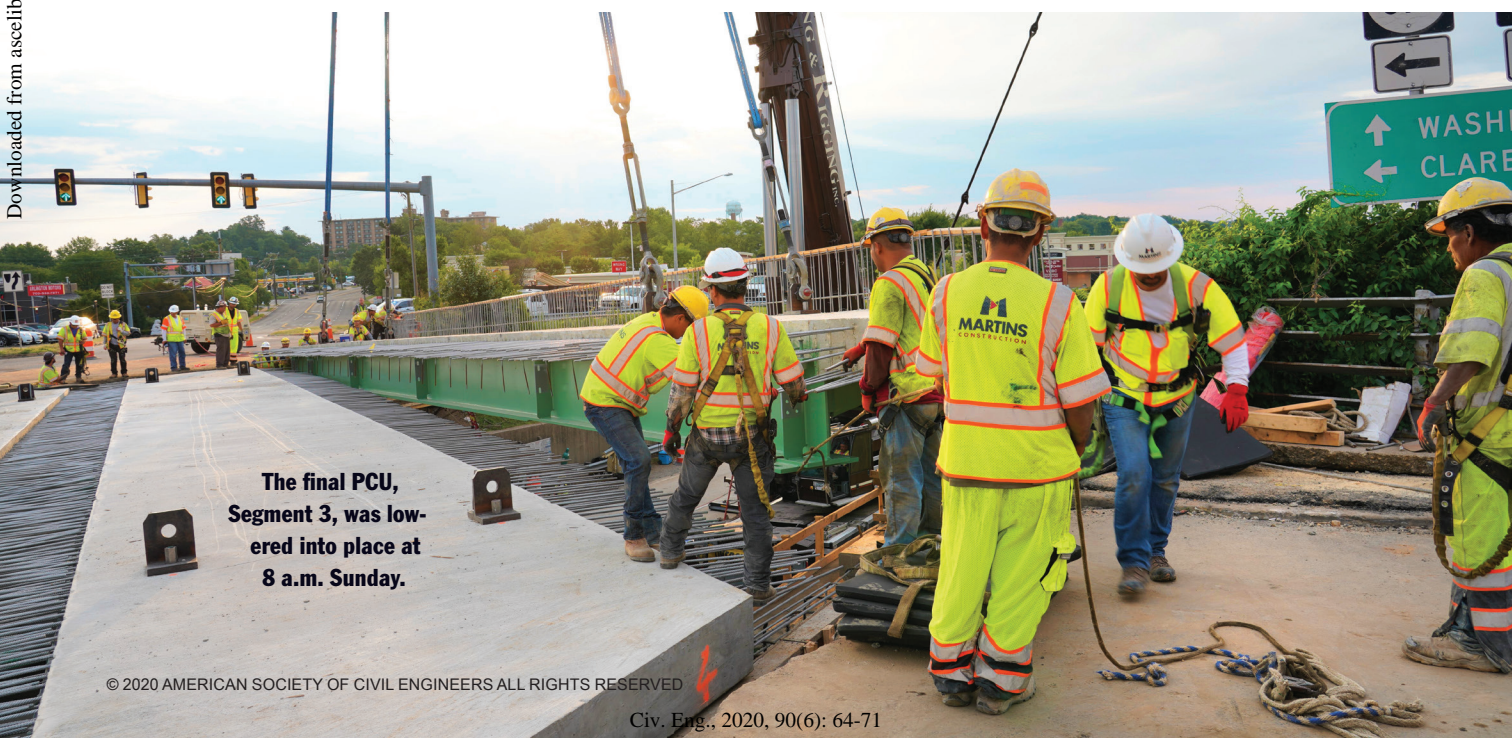
The final PCU, Segment 3, was lowered into place at 8 a.m. Sunday.

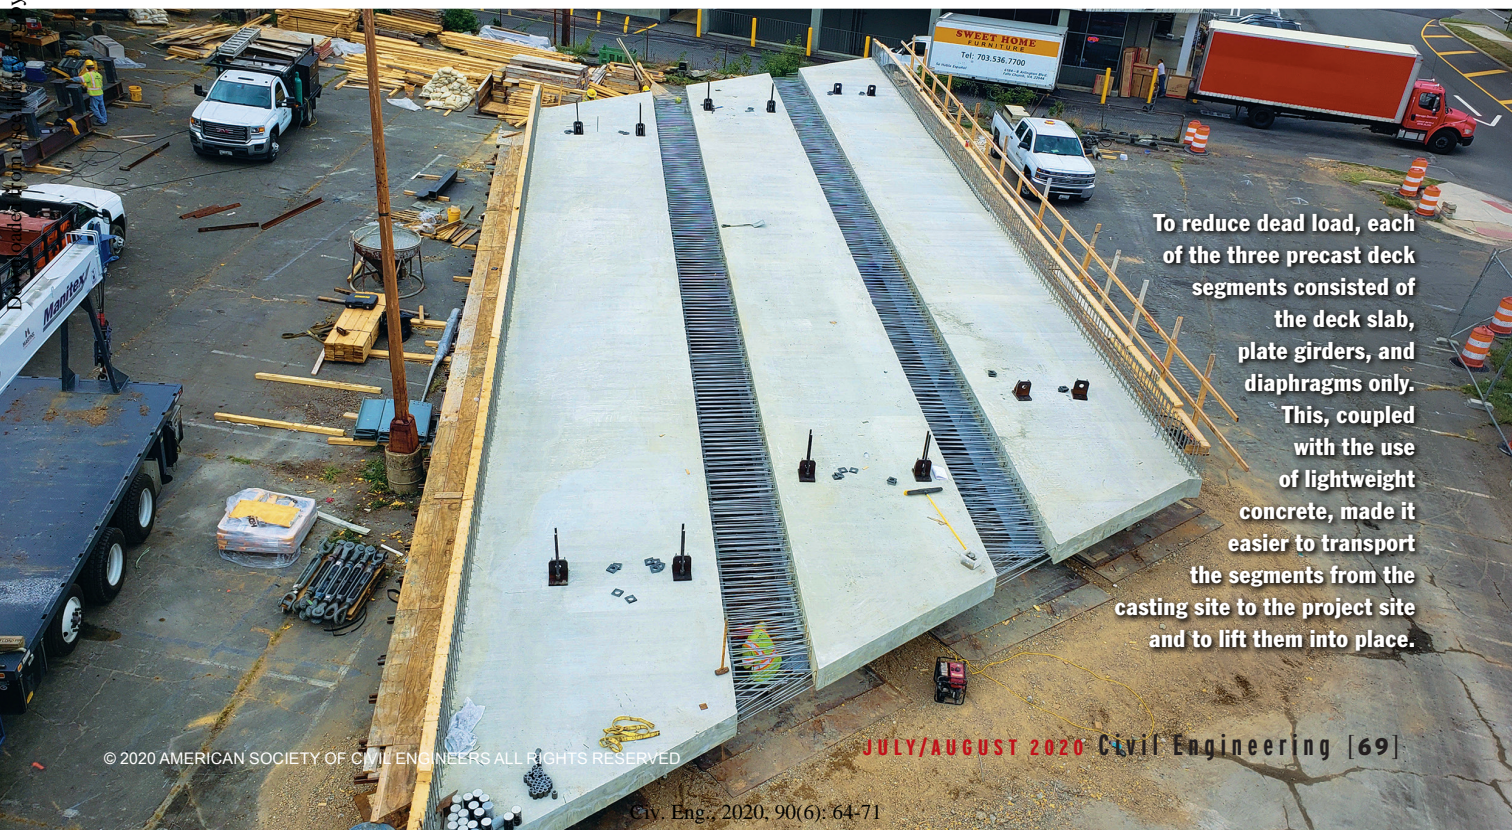
To reduce dead load, each of the three precast deck segments consisted of the deck slab, plate girders, and diaphragms only. This, coupled with the use of lightweight concrete, made it easier to transport the segments from the casting site to the project site and to lift them into place.
